AGENCY: Nevada Department of Transportation
 Aviation Planning Section

LOCATION: Yerington Municipal Airport (122.8)
 Yerington, NV

PAGE TITLE: 2018 Pavement Condition Index Map

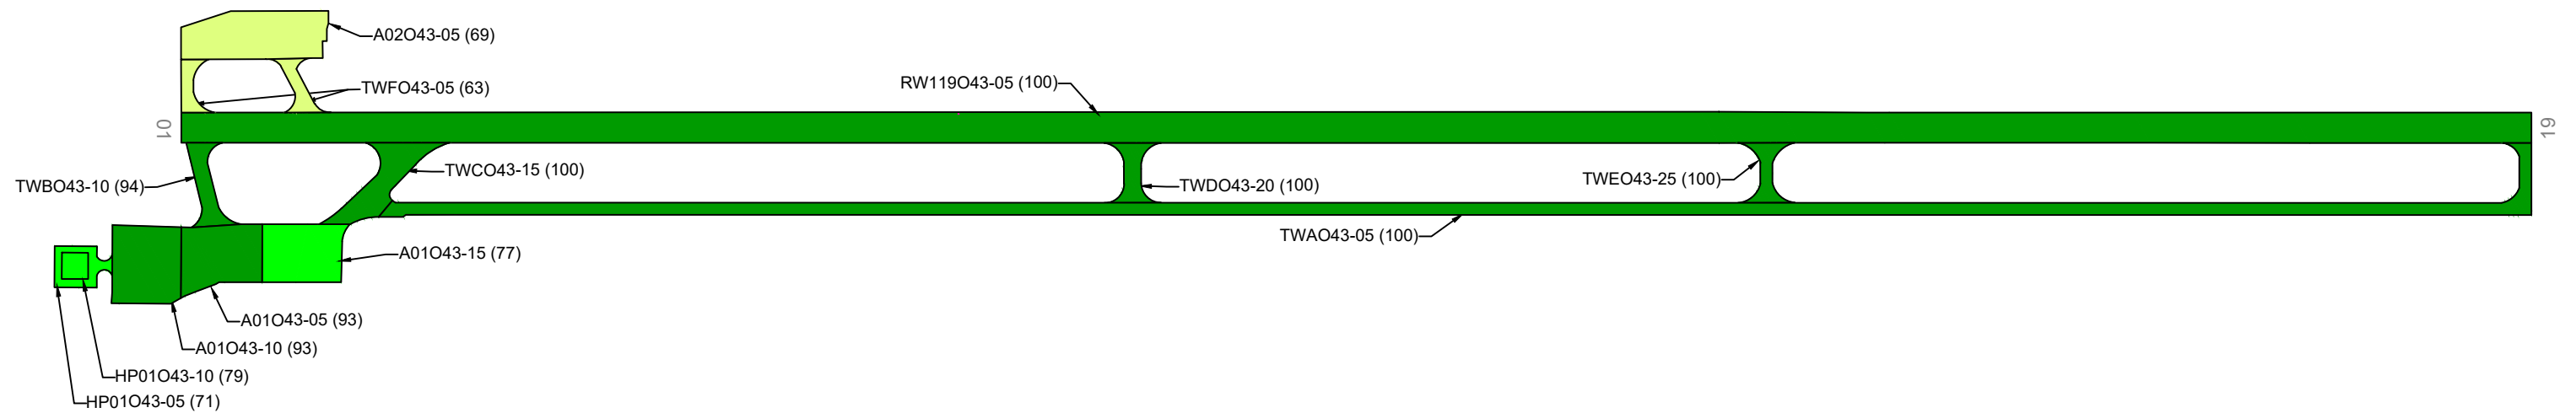
PAVEMENT CONDITION INDEX

PCI	REPAIR
100	PREVENTIVE MAINTENANCE
85	
70	MAJOR REHABILITATION
55	
40	
25	
10	RECONSTRUCTION
0
